# RETROFIT METAL ROOFING PROJECT

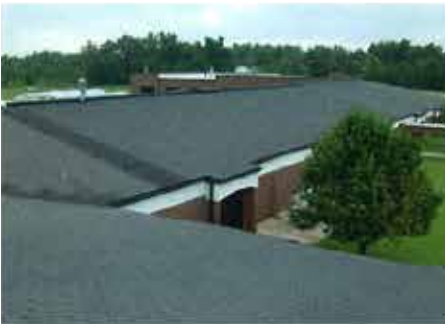
**Before** (Classroom-shingles, Gym-flat roof)

- Flat built-up and sloped shingle
- Bar joist and metal deck
- Minimal insulation

- Blistering
- Saturated insulation
- Severe leaking problems

- Fully engineered roof system
- Sloped steel sub-framing system with variable pitch
- Gable and valley roof design
- No existing roof removal
- 6" fiberglass insulation added to gym
- Exterior gutters and downspouts
- Attached roofing system to structural roof elements only
- 24 gauge standing seam roof panels with flat pan and 2" vertical rib - galvalume over gym and painted over classrooms

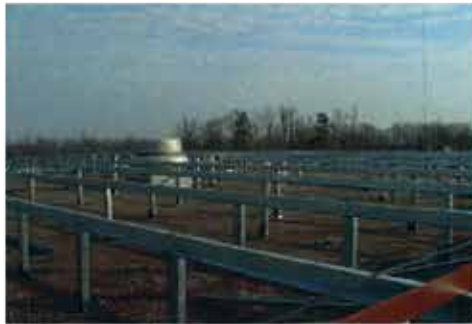
**Gym with framing to add slope**

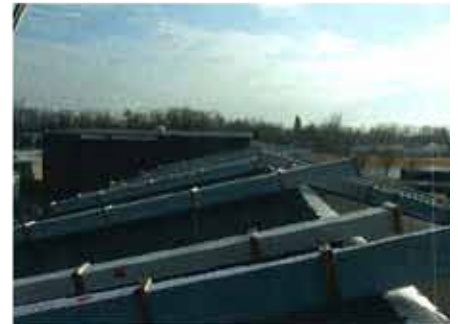
**Classrooms during construction**
