RETROFIT METAL ROOFING PROJECT

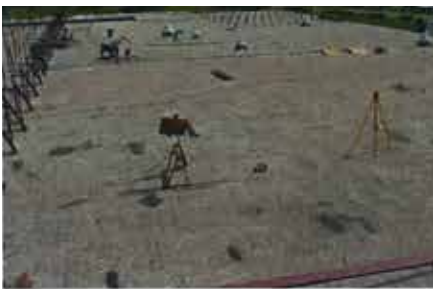
Existing ponding, leaking roof

- Blistering
- Saturated insulation
- Severe leaking problems

- Fully engineered roof system
- Sloped steel sub-framing system with 1/2":12" pitch
- Gable and valley roof design
- No existing roof removal
- 6" fiberglass insulation added
- Exterior gutters and downspouts
- Attached roofing system to bar joist only
- 24 gauge Galvalume® standing seam roof panels with flat pan and 2" vertical rib, Kynar paint on exposed surface

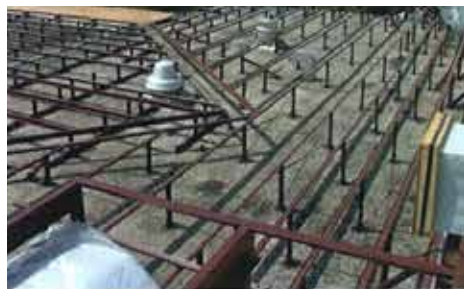
Sub-framing in place

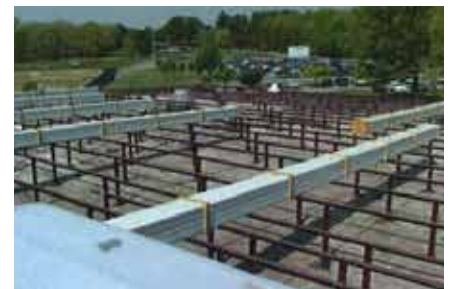
Roof under construction
